NRL Project 62R05-19B

Technical Memo No. 233

ULTRASONIC INSPECTION OF TUNGSTEN ROUND ROBIN BILLETS, PHASE III

27 May 1963

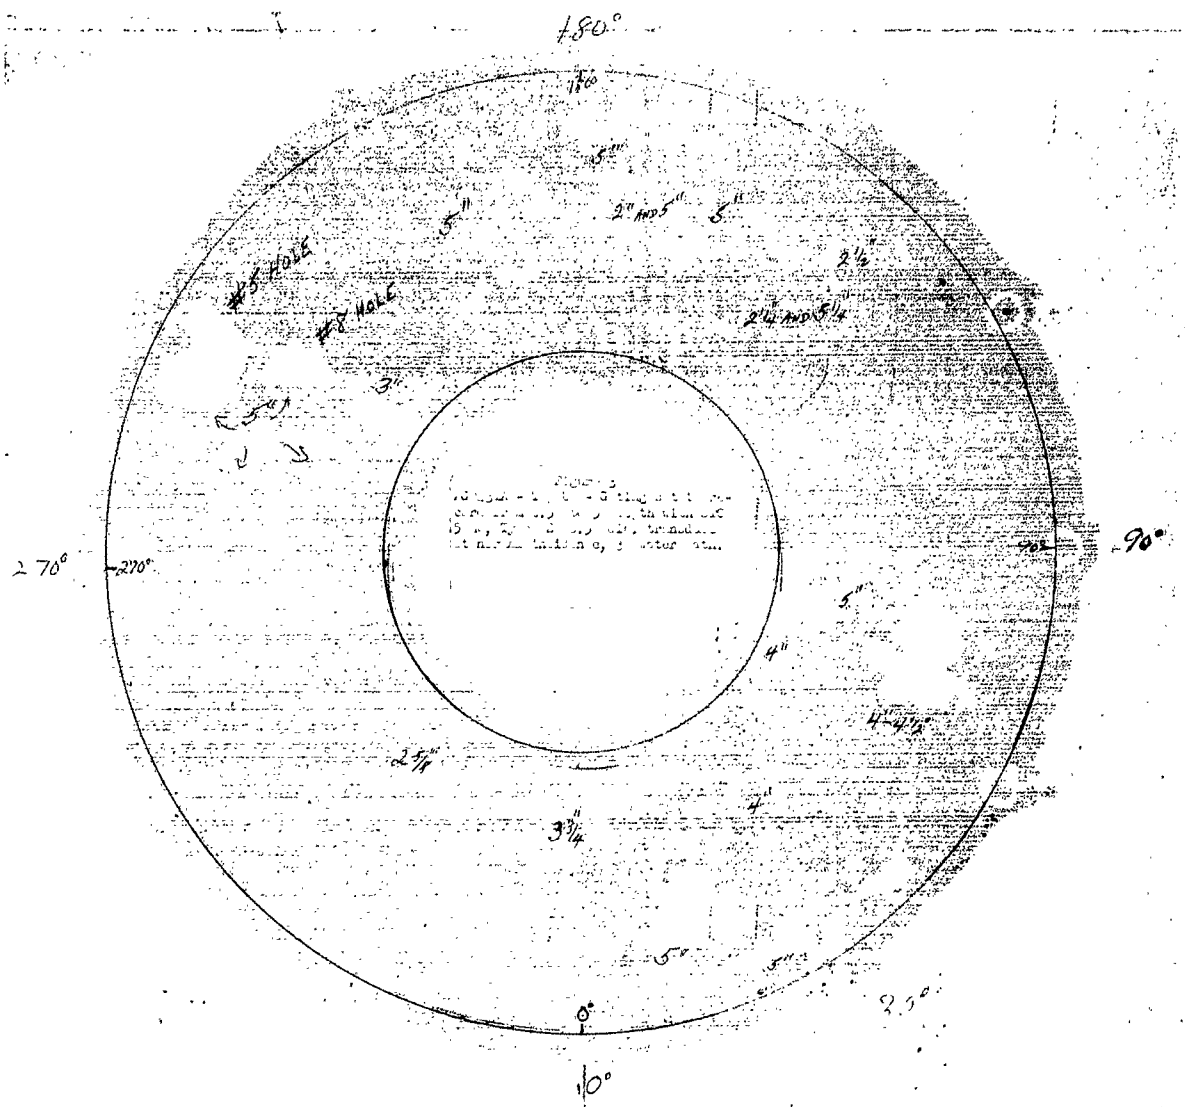
This billet was inspected in a manner similar to that of AG 2230A. Namely, top up and bottom up. Figures 3 and 4 show the actual inspection results. To save time, the flaw gate was set to record all defects of sufficient amplitude from a depth of 0.5 inches to 5.0 inches, rather than in depth increments of one inch. In addition, binder head screws were taped around the circumference of the billet at 30° increments to obtain a more accurate location of "defective" areas. These can be seen in Figures 3 and 4 as circular outlines. This is a much more accurate means of flaw location on round billets. If one had a number of these billets to inspect, a hinged prefabricated plastic appliance could be made to fit around the circumference of the billet. This would not only facilitate flaw location, but it would also help reduce "edge effect".

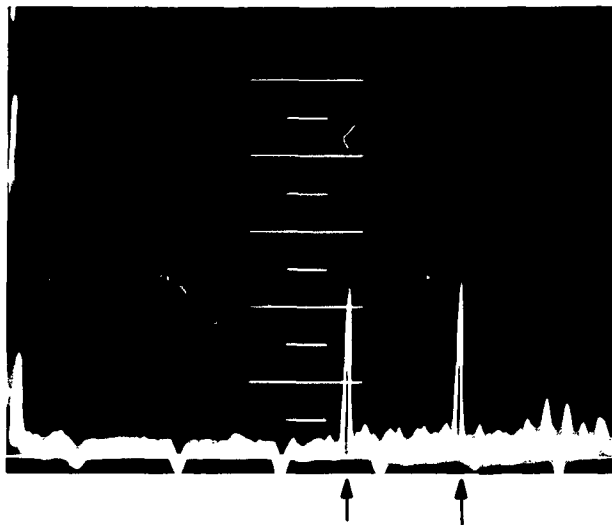
Several photographs of the observed oscillograms were taken to clarify statements made in this report. Keep in mind that the Immerscope sensitivity was set to obtain 100% signal amplitude from a #3 FBH, but the recording level was set to record at a 50% amplitude level. This is necessary in order to obtain recordings of marginal defects. Figure 5 shows an area at 15° in AG2230A. Two distinct defects can be seen at depths of 3.6 and 4.8 inches. Since both defects are less than 50% amplitude, neither would be recorded. Now refer to Figure 6 - on the same scan at an angle of 10°, one defect is increasing in amplitude as the other

Fig 5 - Defects in AG2230A at
15° at depth of 3.6" and 4.8"

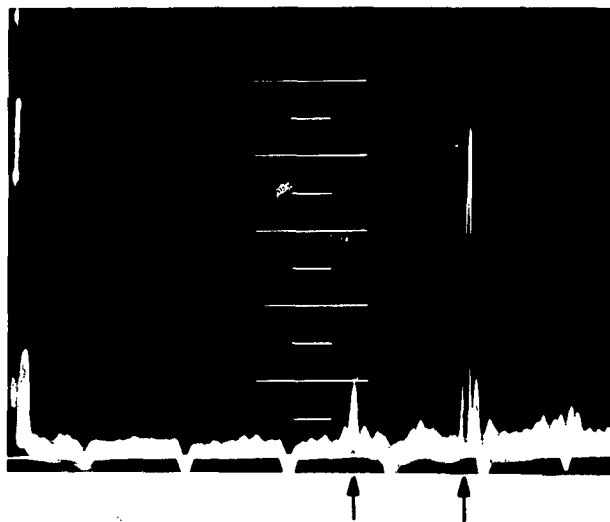
is decreasing. The larger amplitude signal is not recording. If an indexing increment of 0.050 inches or less is used, the defect will clearly show on the recording, but if larger indexing increments are used it could be easily missed. A good "rule of thumb" is that the smallest desired area to be detected, should be recorded on a minimum of three successive index increments.

Fig 6 - Same defects as above
but at 10°

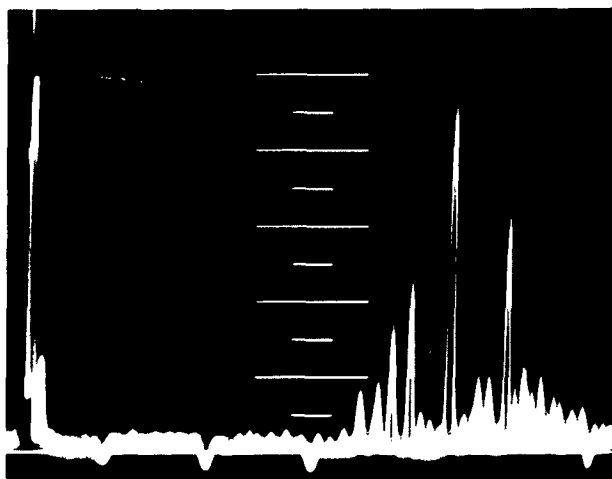
Since the word "crack" is not very scientific, Figure 7 will possibly help define it. This is an oscillogram of an area in AG2230A at 210°. Note the varying amplitude and baseline noise.

Fig 7 - Area in AG2230A at 210°
